# Fire TYPE TEST REPORT

## FP14153-01-1

**THE FIRE RESISTANCE IN ACCORDANCE WITH  
AS 1530.4:2014 OF PIPE AND CABLE PENETRATION  
SPECIMENS INSTALLED IN A PLASTERBOARD LINED  
STEEL STUD WALL**

**Soudal Limited**  
14 Avalon Drive  
Nawton  
Hamilton, 3200  
New Zealand

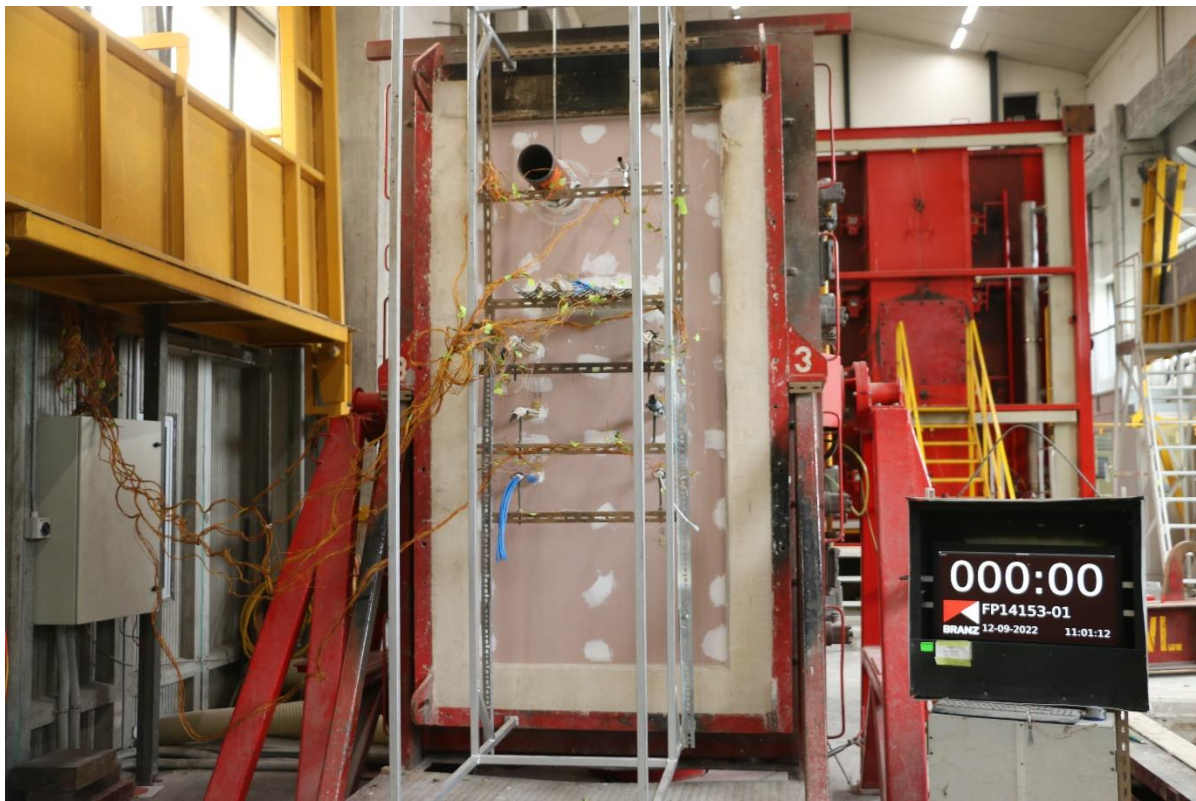
Photo 1: The Unexposed Face of the Specimen Prior to Testing

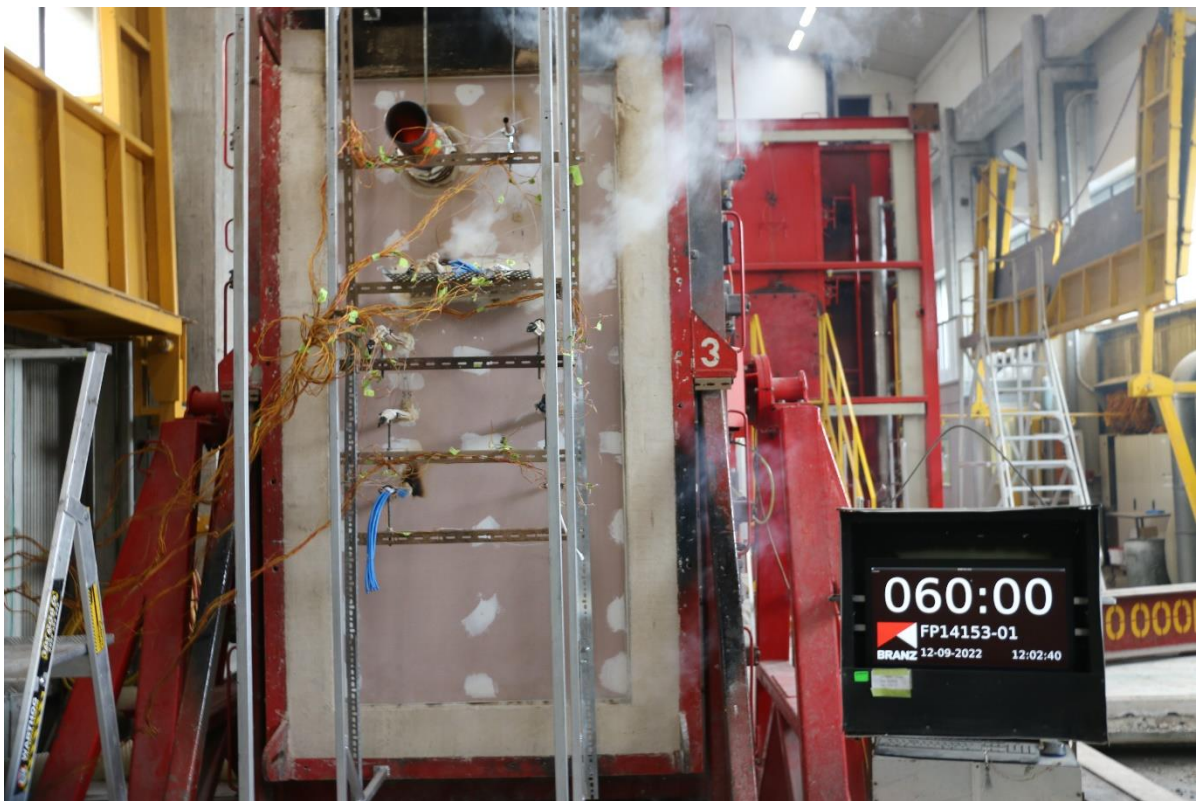
Photo 3: The Unexposed Face of the Specimen After a Duration of 60 Minutes

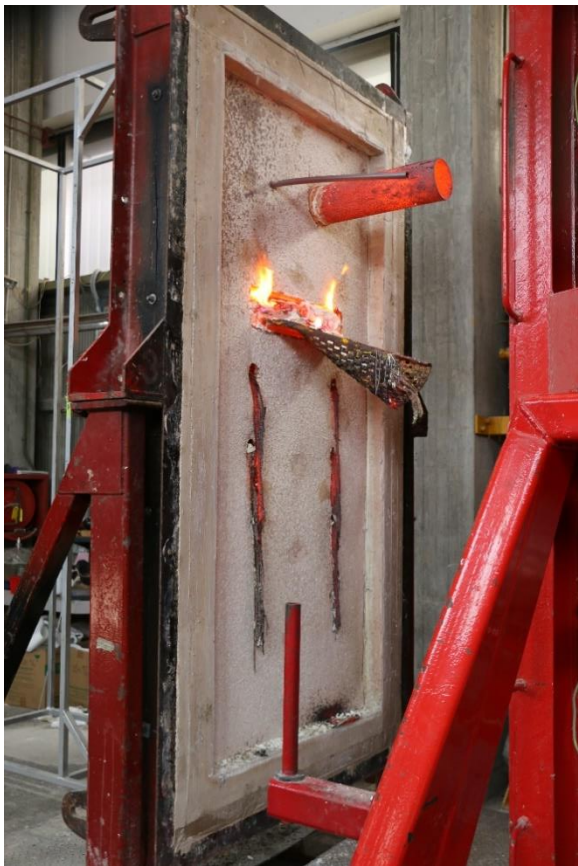
Photo 6: The Exposed Face of the Specimen Immediately After Testing
